**Part
B**

Opportunities, Constraints, &
Preliminary Design

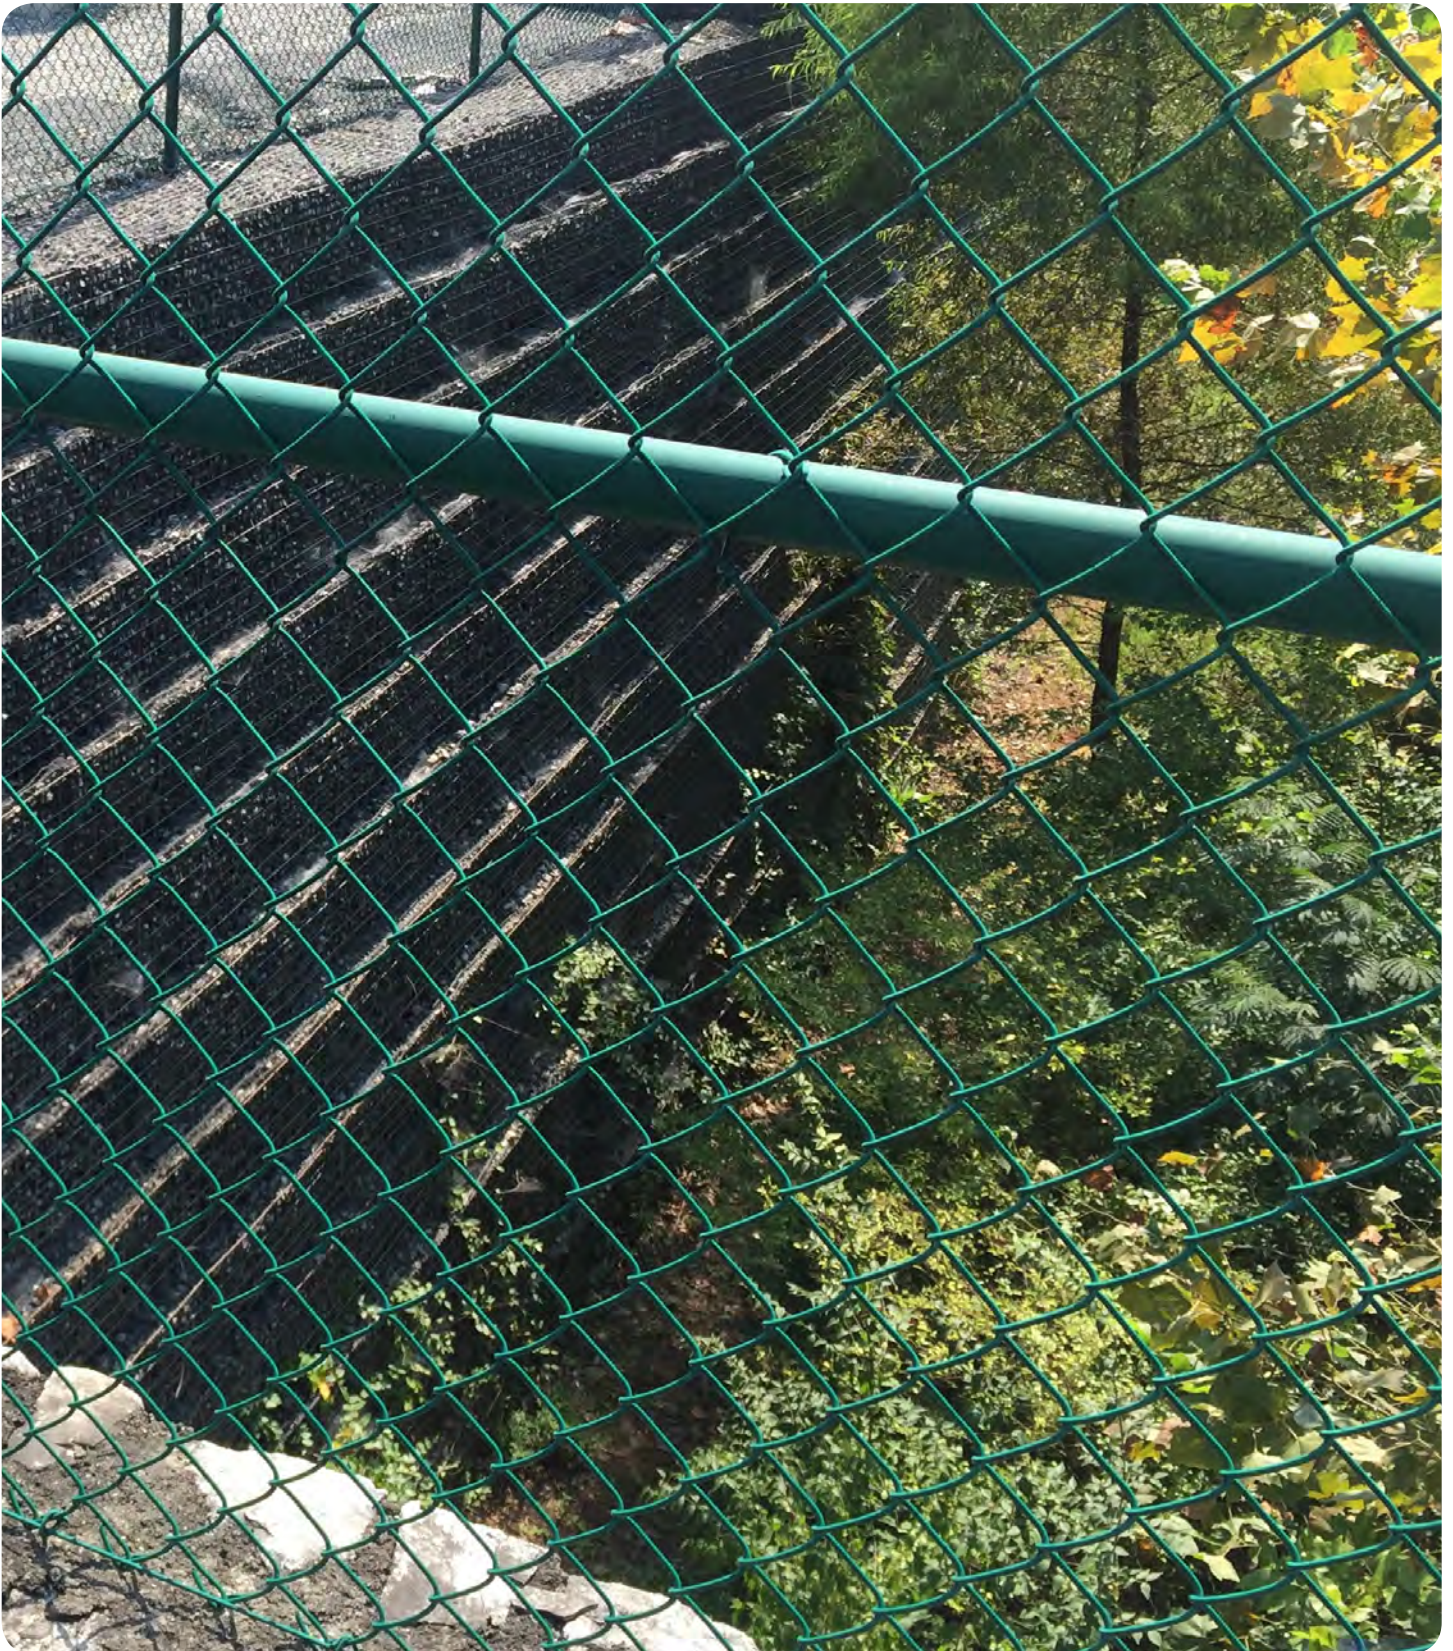
Map 1

Opportunities and Constraints Notes:
